A simulated bushfire test report

An enclosed deck tested in accordance with AS 1530.8.1:2018

Product: Urbanline Architectural Tractio Edge Board

Job number: FRT190063

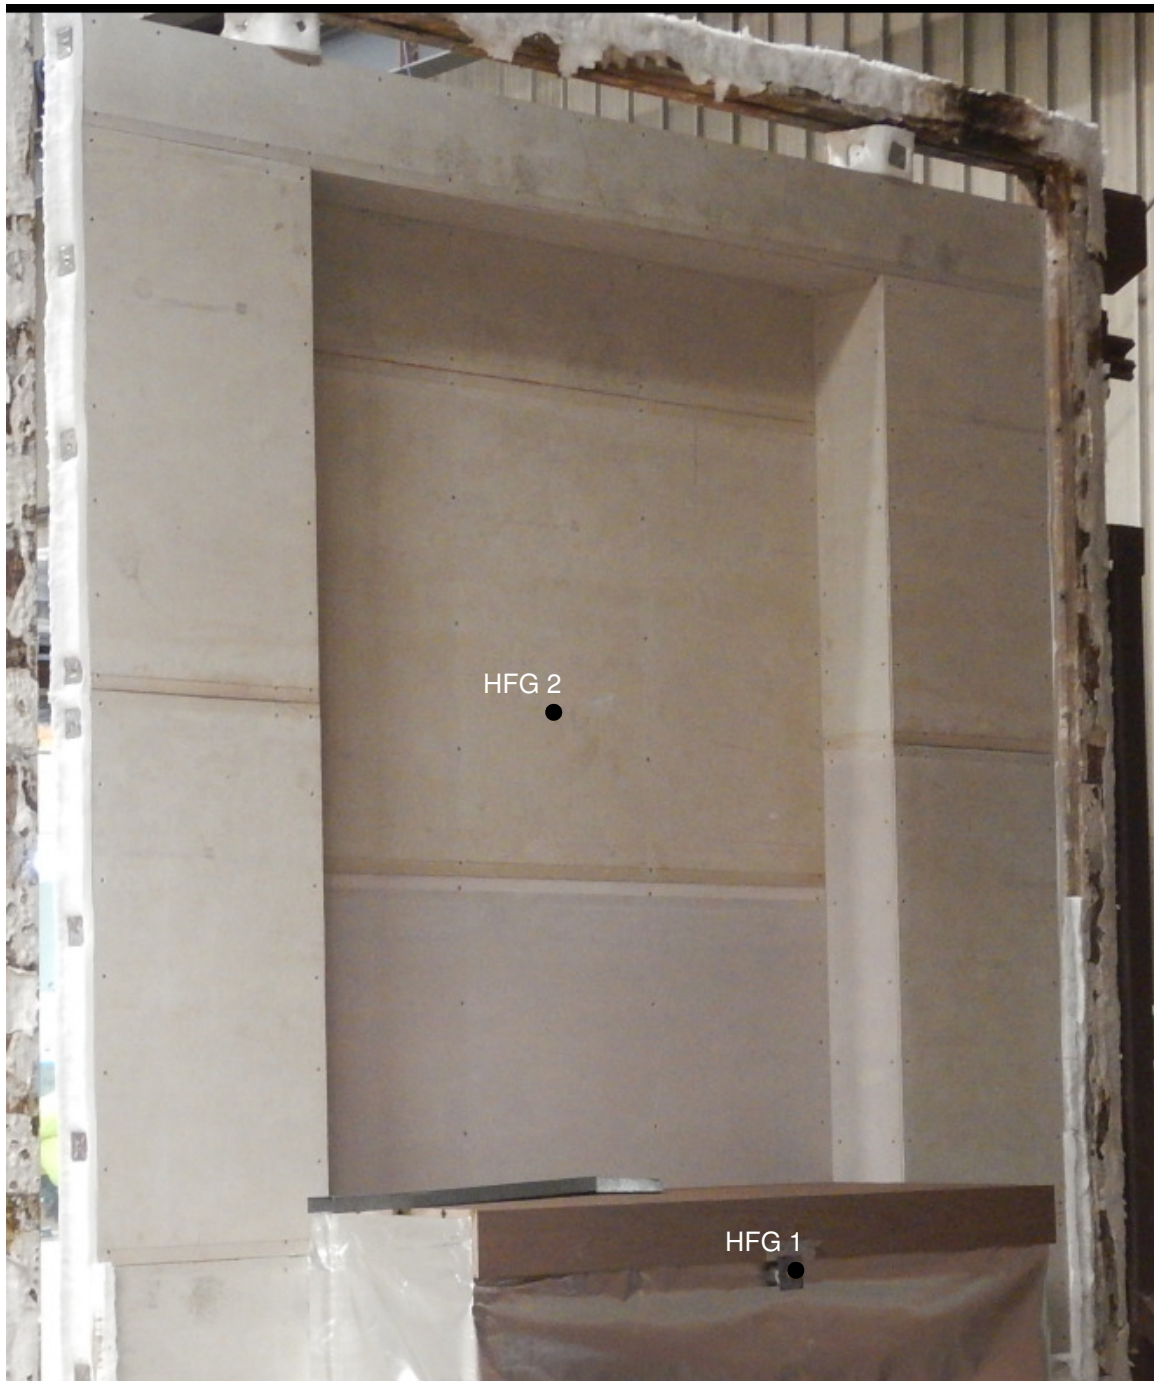
Figure 4 Indicative heat flux gauge locations (exposed face)

Note: HFG 1 centrally located across the deck, nominal 50mm below the bottom of the deck.

HFG 2 located at the centre of the wall

The crib was located at the south-east corner of the deck

- Heat flux gauge (HFG 1) was located centrally across the deck, a nominal 50mm below the bottom of the deck.
- Heat flux gauge (HFG 2) was located centrally to the wall, on the exposed face.

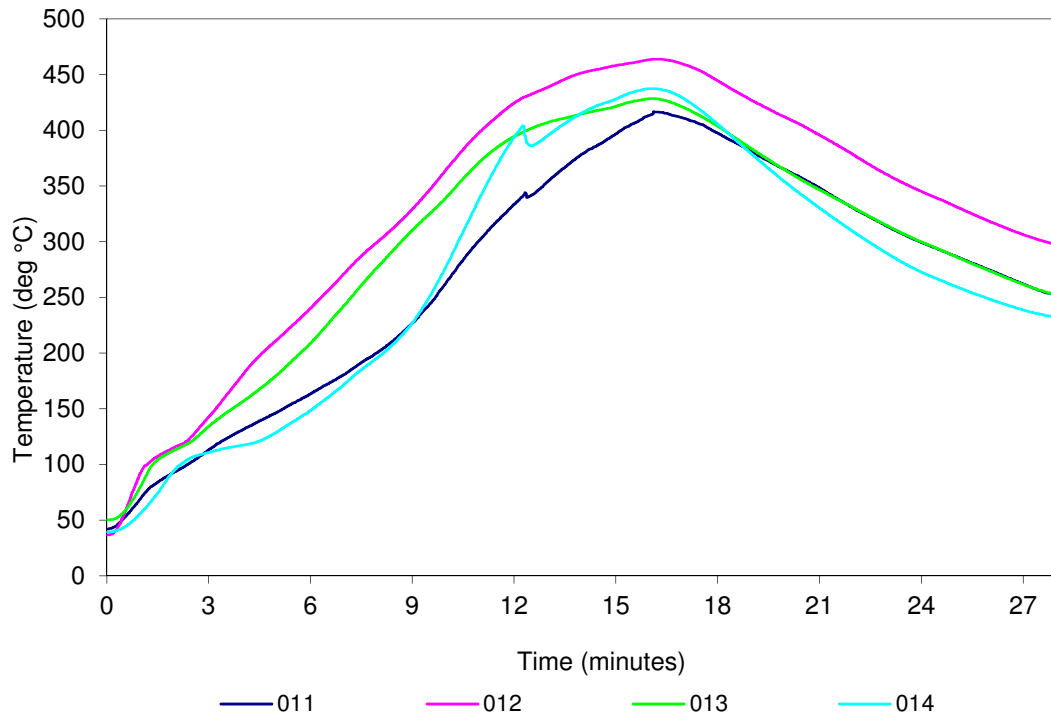
Figure 7 Internal crib temperatures – temperature vs time

Location	T/C no.	Description ²	Temp (°C) at t (minutes)				Limit ¹ (minutes)
			t=0	t=15	t=20	t=27	
Internal crib	011	On the unexposed side of the external lining sheet, behind the crib 27mm above the top of the deck on the east side	42	396	365	262	20
	012	On the unexposed side of the external lining sheet, behind the crib 27mm above the top of the deck on the south side	37	458	412	307	20
	013	On the unexposed side of the external lining sheet, behind the crib 150mm up from TC 011 at the east side	50	421	364	262	20
	014	On the unexposed side of the external lining sheet, behind the crib 150mm up from TC 012 at the south side	39	428	354	239	20
	011	On the unexposed side of the external lining sheet, behind the crib 27mm above the top of the deck on the east side	42	396	365	262	20
Eaves	021	Eave above the crib.	44	115	109	93	-
	022	Eave at the middle of the specimen.	48	100	92	87	-
	023	Eave above the north door reveal.	44	82	76	71	-

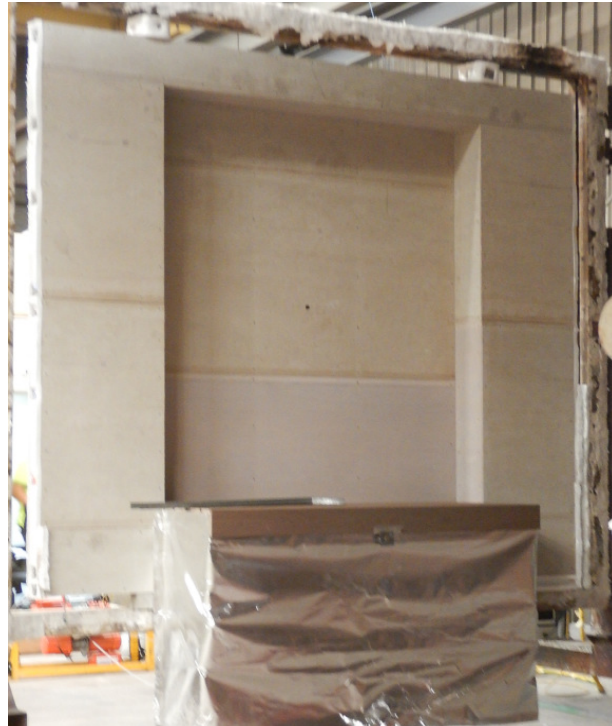
Figure 9 Exposed face of the specimen before the start of the bush fire test

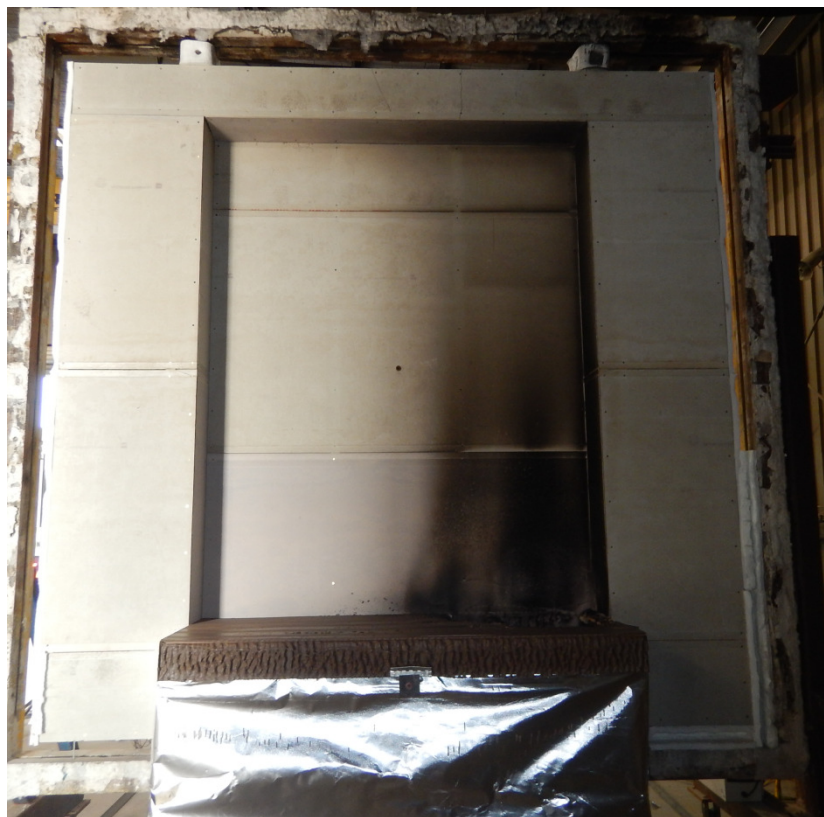
Figure 10 Exposed face of specimen at the end of the bush fire test

10	12	Flaming of the upper deck boards continued.
15	12	Flame spread had exceeded the 500mm limits on the decking boards. Failure in accordance with AS 1530.8.1:2018 clause 21.5, where flaming of the deck assembly had extended by more than 500mm in any direction from the rear and side walls.
20	00	TC 012 located on the unexposed side of the fibre cement cladding at the mid-height and adjacent to the crib recorded a temperature of 412°C. Failure in accordance with AS 1530.8.1:2018 clause 14.4 (e), where the maximum temperature of the internal faces of construction including cavities exceeded 300°C between 20 minutes and 60 minutes after the commencement of the test.
27	35	Flaming of the upper deck board had extended to the west edge of the decking and up to mid-width of the deck. Specimen flaming was extinguished due to safety reasons.
27	35	The test was terminated due to safety reasons.
